**Colorado Cultural Resource Survey
Management Data Form**
(page 1 of 4)

5. Resource Name: Allard Ranch - Arapaho National Wildlife Refuge Headquarters
6. Project Name/Number: _____
7. Government Involvement: Local__ State__ Federal X
Agency: U. S. Fish and Wildlife Service
8. Site Categories: Check as many as apply
Prehistoric: archaeological site__ paleontological site__
in an existing National Register District? yes__ no__ name_____
Historic: archaeology site__ building(s) X structure(s)__ object(s)__
in an existing National Register District? yes__ no X name_____
9. Owner/Owner's Address: Arapaho National Wildlife Refuge - Walden, CO
10. Boundary Description and Justification: Extent of Historic Complex

Colorado Cultural Resource Survey
Historic Architectural Building/Structure Form

5JA784: Arapahoe National Wildlife Refuge Headquarters
Allard Ranch

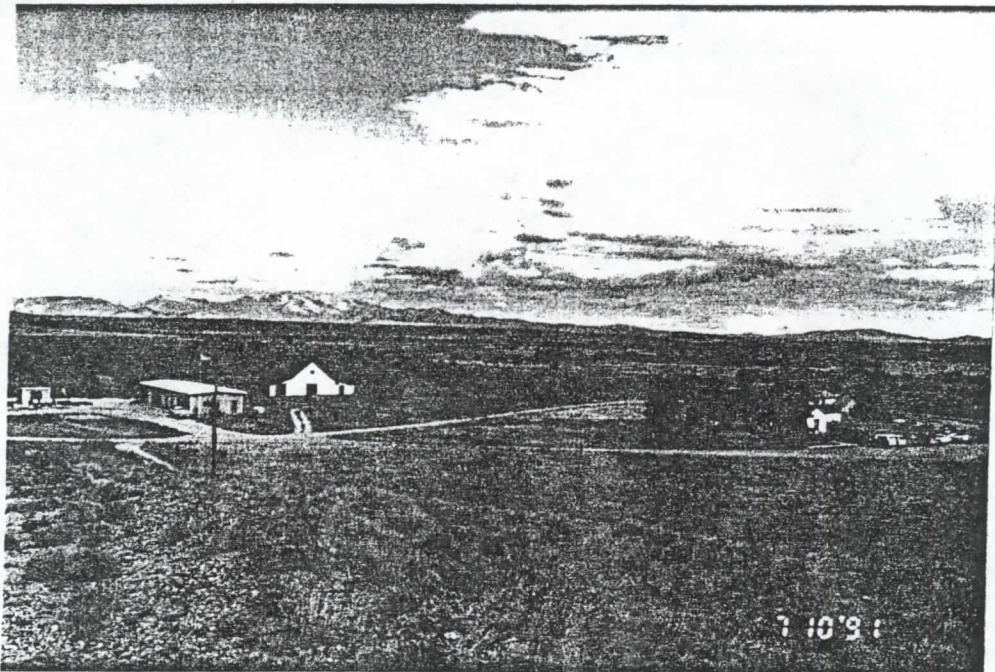
7. Complex / Building / Structure Type: Barn
8. Architectural Style: Frame Vernacular
9. Building Support System: Not Observed 10. _____
- Dimensions: L: 64.4 x W: 58.4 = Square Feet: 3761
11. Number of Stories: 2 including loft
12. Building Plan (Footprint, shape): Compound Plan, Rectangular
13. Landscaping or Special Setting Features: The structure is located on the floodplain of the Illinois River

15. Roof: Asphalt Shingle, Front Gable with two side shed roofs
16. Walls: The walls are vertical boards.
- _____ 17. _____
- Foundation/Basement: None - the floors are wooden
18. Chimney(s): NA

22. General Architectural Description: The structure is a wood frame barn. The barn is obviously original, but there is a discrepancy between the measurements and configuration of the structure listed by the assessor in 1966 and the actual specifications. See the table and 1966 map for information.

FEATURE 3: Allard Ranch Barn, Facing Northwest
